**Flood Control Project Maintenance
Levee Inspections**

Maintenance Issue Types Only, Levee Inspection Report By Mile - Spring 2019

Reclamation District No. 1001 Nicolaus

Waterway	Bank	Unit Miles	Inspection Start/End	Inspector
Unit No. 01 Yankee Slough	Right	4.12	03/12/2019 03/12/2019	Sterling York

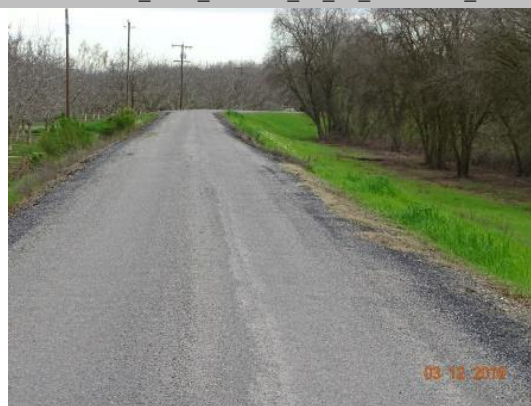
Photo 1 of 1 : SP_2019_RD1001_36_11_20190320_00015.jpg

LM Start	0.00	Rating **	A	Issue No.	11
LM End	3.86	Issue Type +	Ma	Location *	WS
Category	Earthen Levee			GPS Latitude/Longitude	
				Start	End
Item	Vegetation			38.980267 °	38.967114 °
				-121.470113 °	-121.533804 °
DWR ID	DWR_RD1001_01_s_2019_11				
Comment Code					
V1 : Control annual grass and weeds on the levee slopes and easements.					
Inspector Comment					
The annual vegetation is well maintained, Spring 2019.

View looking upstream waterside of the well maintained annual vegetation, Spring 2019.

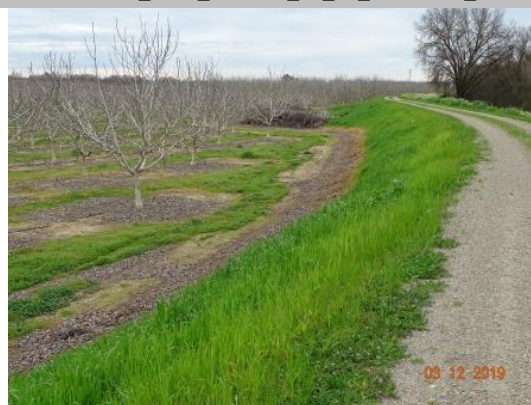
Photo 1 of 1 : SP_2019_RD1001_36_10_20190320_00014.jpg

LM Start	0.00	Rating **	A	Issue No.	10
LM End	3.86	Issue Type +	Ma	Location *	LS
Category	Earthen Levee			GPS Latitude/Longitude	
				Start	End
Item	Vegetation			38.980267 °	38.967114 °
				-121.470113 °	-121.533805 °
DWR ID	DWR_RD1001_01_s_2019_10				
Comment Code					
V1 : Control annual grass and weeds on the levee slopes and easements.					
Inspector Comment					
The annual vegetation is well maintained, Spring 2019.

View looking upstream landside of the well maintained annual vegetation, Spring 2019.

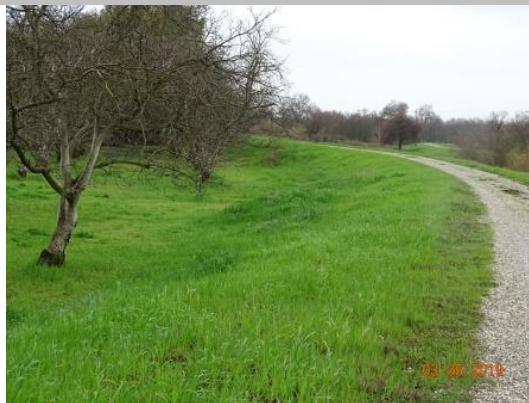
Photo 1 of 1 : SP_2019_RD1001_35_7_20190320_00027.jpg

View looking downstream landside at the well maintained annual vegetation, Spring 2019.

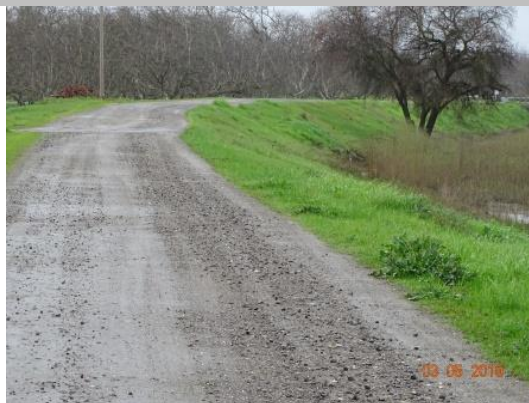
Photo 1 of 1 : SP_2019_RD1001_35_8_20190320_00028.jpg

LM Start	0.01	Rating **	A	Issue No.	8
LM End	3.64	Issue Type +	Ma	Location *	WS
Category	Earthen Levee			GPS Latitude/Longitude	
				Start	End
Item	Vegetation			38.971342 °	38.965811 °
				-121.473997 °	-121.533591 °
DWR ID	DWR_RD1001_02_s_2019_8				
Comment Code					
V1 : Control annual grass and weeds on the levee slopes and easements.					
Inspector Comment					
The annual vegetation is well maintained, Spring 2019.

View looking downstream waterside at the well maintained annual vegetation, Spring 2019.

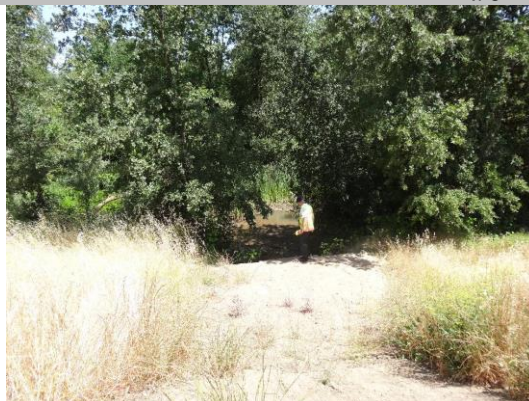
Photo 1 of 3 : UCIP_SP_2019_14008_23108.jpg

LM Start	2.28	Rating **	M	Issue No.	55
LM End	2.28	Issue Type +	Ma	Location *	
Category	Supplemental			GPS Latitude/Longitude	
				Start	End
Item	DWR UCIP LMA Responsibility			38.967403 °	38.967403 °
				-121.510953 °	-121.510953 °
DWR ID	22543				
Comment Code					
Inspector Comment					
FS_ID:14008 DS_ID:22543 EP_NO: N/A Repair Type: Non-Urgent Crossing Status: Found UCIP Comments: 05/23/2013 - slide gate in inlet pipe on landside - pits on pipe due to corrosion (P. Amatya - DWR UCIP) FIELD_STRUCT_DESC: 36-inch corrugated metal gravity drainage pipe through the levee, 15 feet below the crown. Flap gate and concrete U-shaped headwall at outfall on the waterside (WS) end. Slide gate at inlet on the landside (LS) end. (Reclamation District No. 1001). [Additional Reference(s): DWR Levee Log, 1993. USACE Sacramento O&M Manual 141.1, August 1955, (Station 67+75)]. FS Date: 5/23/2013

WS- overview of waterside of the levee.

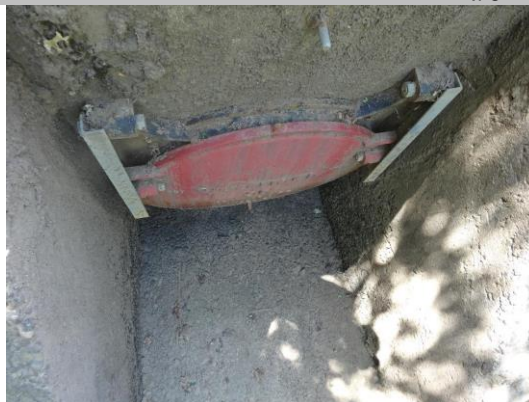
Photo 2 of 3 : UCIP_SP_2019_14008_23107.jpg

WS- outfall pipe with flap gate in concrete wing wall.

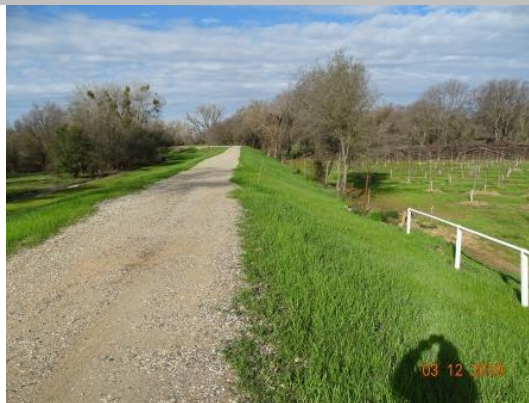
Photo 1 of 2 : SP_2019_RD1001_37_8_20190320_00040.jpg

View looking downstream waterside east of the RR Tracks at the well maintained annual vegetation, Spring 2019.

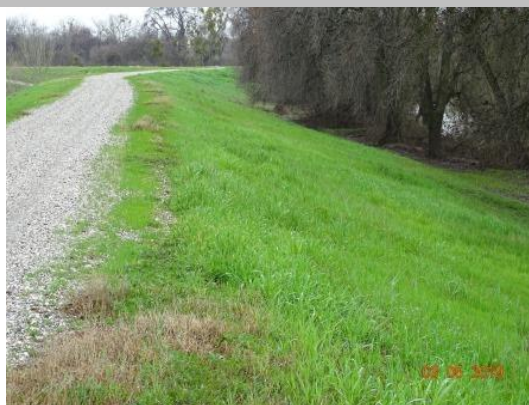
Photo 2 of 2 : SP_2019_RD1001_37_8_20190320_00039.jpg

View looking downstream waterside west of the RR Tracks at the well maintained annual vegetation, Spring 2019.

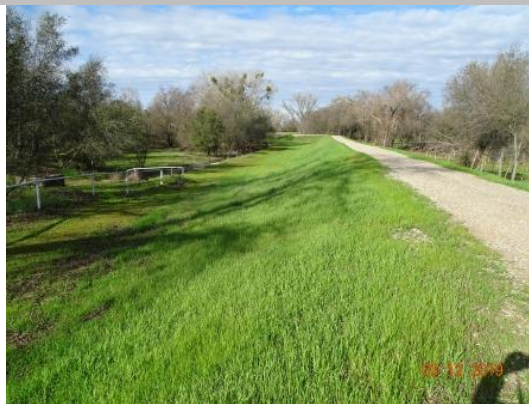
Photo 1 of 2 : SP_2019_RD1001_37_6_20190320_00038.jpg

LM Start	0.01	Rating **	A	Issue No.	6
LM End	12.57	Issue Type +	Ma	Location *	LS
Category	Earthen Levee			GPS Latitude/Longitude	
				Start	End
Item	Vegetation			39.006576 °	38.941182 °
				-121.375131 °	-121.567543 °
DWR ID	DWR_RD1001_03_s_2019_6				
Comment Code					
V1 : Control annual grass and weeds on the levee slopes and easements.					
Inspector Comment					
Well maintained annual vegetation, Spring 2019.

View looking downstream landside east of the RR Tracks at the well maintained annual vegetation, Spring 2019.

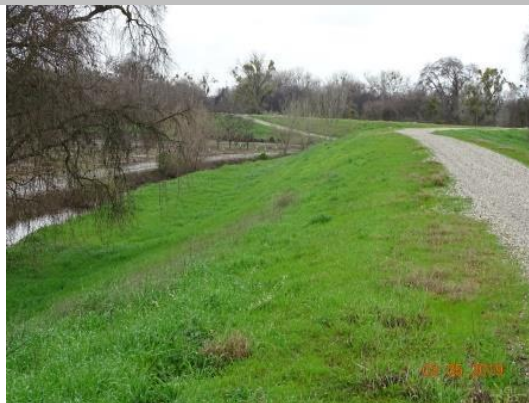
Photo 2 of 2 : SP_2019_RD1001_37_6_20190320_00037.jpg

View looking downstream landside west of the RR Tracks at the well maintained annual vegetation, Spring 2019.

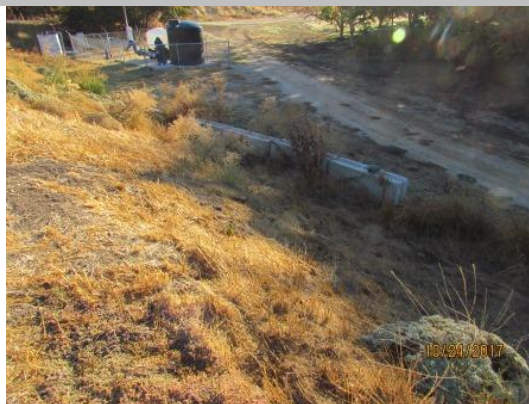
Photo 1 of 1 : SP_2019_RD1001_37_29_20190305_00019.jpg

LM Start	1.87	Rating **	A/W	Issue No.	29
LM End	1.87	Issue Type +	Ma	Location *	LS
Category	Earthen Levee			GPS Latitude/Longitude	
				Start	End
Item	Slope Stability			38.998608 °	38.998608 °
				-121.405570 °	-121.405570 °
DWR ID	DWR_RD1001_03_s_2013_29				
Comment Code					
S3 : Repair the levee slope damaged by vehicle traffic and prevent access where possible.					
Inspector Comment					
Continual damage caused by vehicles going around the gate, has been fixed and blocks added.

Continual damage caused by vehicles going around the gate.

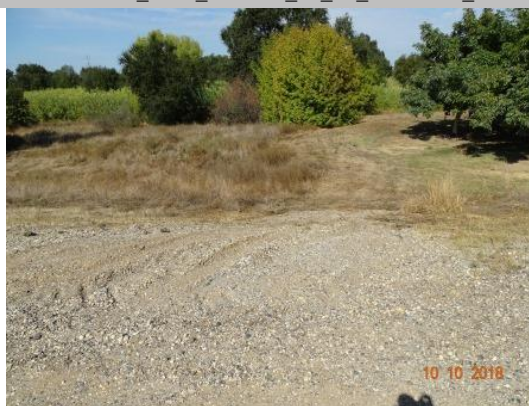
Photo 1 of 1 : SP_2019_RD1001_37_30_20190305_00020.jpg

LM Start	2.28	Rating **	M	Issue No.	30
LM End	2.28	Issue Type +	Ma	Location *	WS
Category	Earthen Levee			GPS Latitude/Longitude	
				Start	End
Item	Slope Stability			38.996302 °	38.996302 °
				-121.412285 °	-121.412285 °
DWR ID	DWR_RD1001_03_s_2013_30				
Comment Code					
S3 : Repair the levee slope damaged by vehicle traffic and prevent access where possible.					
Inspector Comment					
Damage to landside slope by vehicles need to be repaired, Spring 2018.

View looking at waterside where slope has been disturbed by vehicle traffic, Fall 2018.

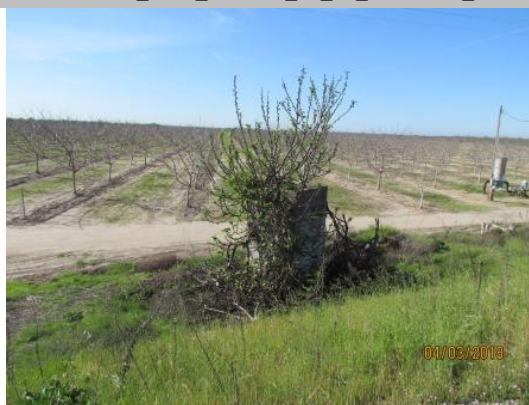
Photo 1 of 1 : SP_2019_RD1001_37_36_20190305_00024.jpg

LM Start	2.59	Rating **	M	Issue No.	36
LM End	2.59	Issue Type +	Ma	Location *	LS
Category	Earthen Levee			GPS Latitude/Longitude	
				Start	End
Item	Trim / Thin Trees			38.995583 °	38.995583 °
				-121.417995 °	-121.417995 °
DWR ID	DWR_RD1001_03_s_2015_36				
Comment Code					
T3 : Trim and thin trees to allow visibility of the ground and room to flood fight.					
Inspector Comment					
Tree less than 4" in diameter should be removed.

View of a small starter tree on landside slope looking downstream that is less than 4" in diameter.

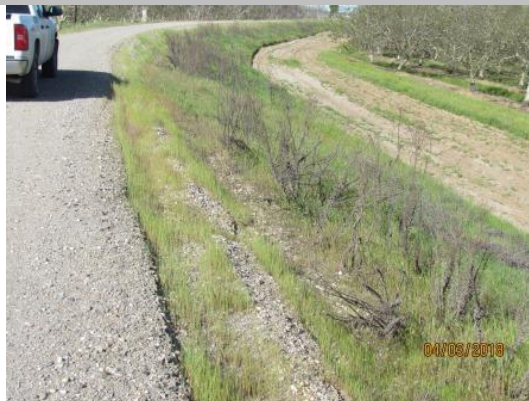
Photo 1 of 1 : SP_2019_RD1001_37_21_20190305_00014.jpg

LM Start	3.57	Rating **	M	Issue No.	21
LM End	3.57	Issue Type +	Ma	Location *	WS
Category	Earthen Levee			GPS Latitude/Longitude	
				Start	End
Item	Erosion / Bank Caving			38.991390 °	38.991390 °
				-121.435268 °	-121.435268 °
DWR ID	DWR_RD1001_03_s_2016_21				
Comment Code					
E2 : Schedule repair of erosion site prior to the next inspection.					
Inspector Comment

Erosion on waterside slope still remains as of Spring 2019.

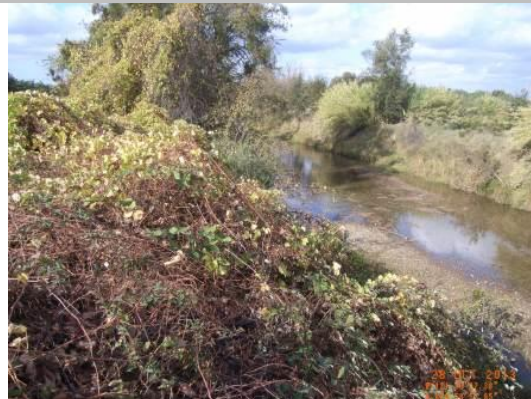
Photo 1 of 1 : SP_2019_RD1001_37_13_20190305_00009.jpg

LM Start	7.22	Rating **	A/W	Issue No.	13
LM End	7.31	Issue Type +	Ma	Location *	WS
Category	Supplemental			GPS Latitude/Longitude	
				Start	End
Item	2017 USACE Erosion Survey, DRAFT			38.982737 °	38.982572 °
				-121.501144 °	-121.502797 °
DWR ID	DWR_RD1001_03_f_2018_13				
Comment Code					
Inspector Comment					
2017 Site ID: BER 5.7 L					
Status: Eroding					
2017 Field Notes: Minor new erosion observed.					
Site History: 2008 - Sandy/silty banks with rotational slab failures creating near vertical bank with pop-outs due to tree failures. Narrow berm.					
Levee Inspector notes: Erosion is not into the levee prism on into the channel bank.

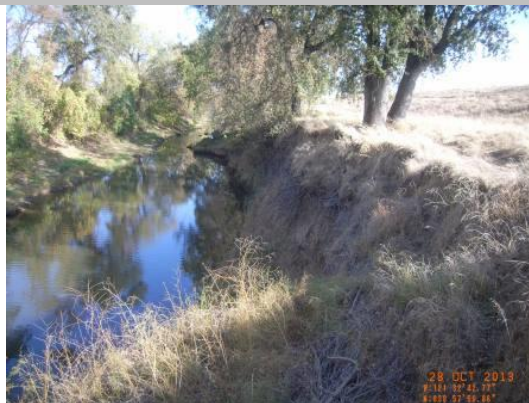
Photo 1 of 1 : SP_2019_RD1001_37_12_20190305_00008.jpg

LM Start	10.36	Rating **	M	Issue No.	12
LM End	10.40	Issue Type +	Ma	Location *	WS
Category	Supplemental			GPS Latitude/Longitude	
				Start	End
Item	2017 USACE Erosion Survey, DRAFT			38.964583 °	38.964010 °
				-121.544967 °	-121.545228 °
DWR ID	DWR_RD1001_03_f_2018_12				
Comment Code					
Inspector Comment					
2017 Site ID: BER 2.5 L					
Status: Eroding					
2017 Field Notes: Erosion pockets have expanded					
Site History: 2011 - Large section of bank has slumped off. RD has flagged and appears to be watching. 2012 - Slopes slightly steeper.					
2013 - Minor new erosion observed.

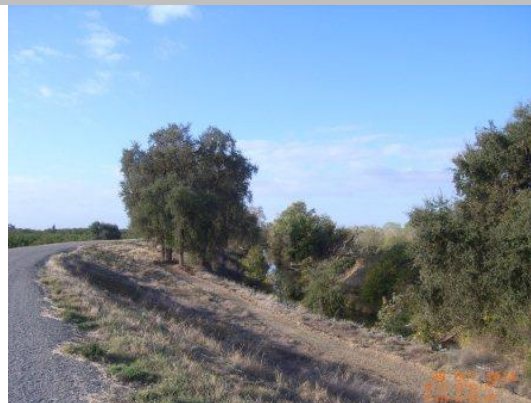
Photo 1 of 1 : SP_2019_RD1001_37_10_20190305_00006.jpg

LM Start	11.08	Rating **	A/W	Issue No.	10
LM End	11.16	Issue Type +	Ma	Location *	WS
Category	Supplemental			GPS Latitude/Longitude	
				Start	End
Item	2017 USACE Erosion Survey, DRAFT			38.955070 °	38.954227 °
				-121.549528 °	-121.550592 °
DWR ID	DWR_RD1001_03_f_2018_10				
Comment Code					
Inspector Comment					
2017 Site ID: BER 1.9 L					
Status: Eroding					
2017 Field Notes: Minor new erosion observed.					
Site History: 2011 - Large slumped sections of bank. 2012 - Slopes slightly steeper.

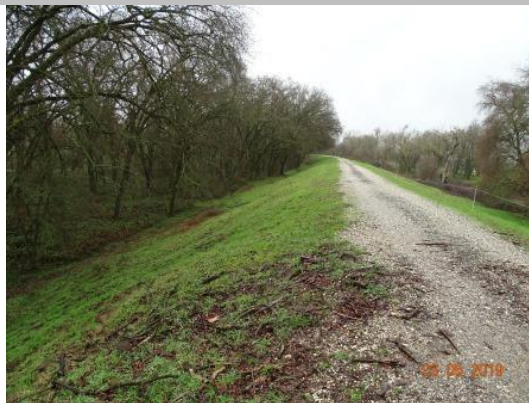
Photo 1 of 1 : SP_2019_RD1001_38_8_20190320_00064.jpg

View looking downstream landside at the well maintained annual vegetation, Spring 2019.

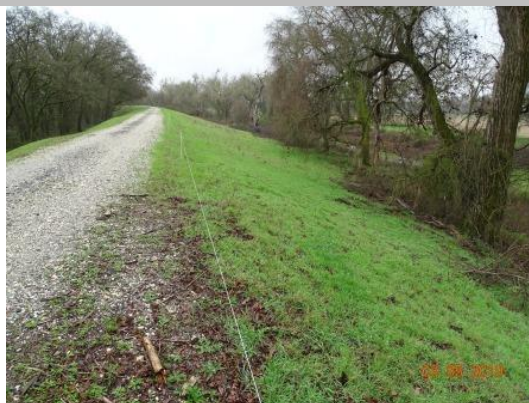
Photo 1 of 1 : SP_2019_RD1001_38_16_20190320_00065.jpg

View looking downstream waterside at the well maintained annual vegetation, Spring 2019.

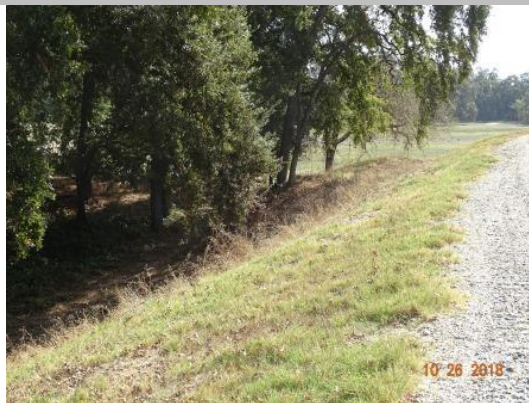
Photo 1 of 2 : SP_2019_RD1001_38_64_20190305_00033.jpg

LM Start	0.37	Rating **	A/W	Issue No.	64
LM End	0.37	Issue Type +	Ma	Location *	LS
Category	Earthen Levee			GPS Latitude/Longitude	
				Start	End
Item	Slope Stability			38.935903 °	38.935903 °
				-121.567250 °	-121.567250 °
DWR ID	DWR_RD1001_04_s_2016_64				
Comment Code					
S1 : Repair slope instability.					
Inspector Comment					
Animal trail is not being used and shows no sign of erosion or sloughing. Fall 2017.

View looking downstream of animal trail that is not being used and shows no sign of erosion or sloughing. Fall 2018.

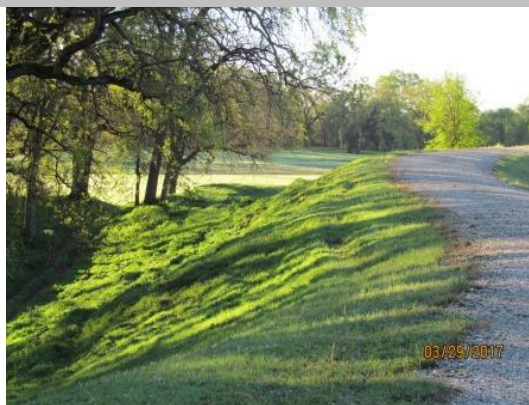
Photo 2 of 2 : SP_2019_RD1001_38_64_20190305_00034.jpg

View looking downstream of animal trail that is not being used and shows no sign of erosion or sloughing. Spring 2017.

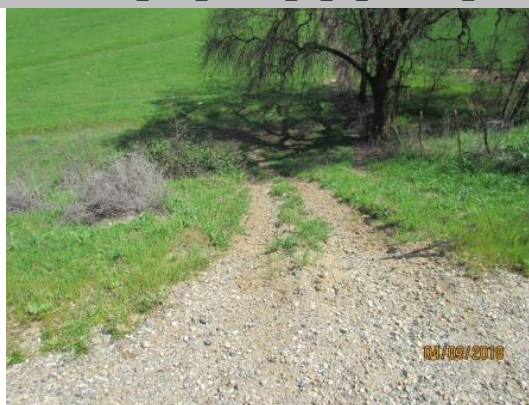
Photo 1 of 1 : SP_2019_RD1001_38_68_20190305_00038.jpg

LM Start	0.55	Rating **	M	Issue No.	68
LM End	0.55	Issue Type +	Ma	Location *	LS
Category	Earthen Levee			GPS Latitude/Longitude	
				Start	End
Item	Slope Stability			38.933299 °	38.933299 °
				-121.567069 °	-121.567069 °
DWR ID	DWR_RD1001_04_s_2016_68				
Comment Code					
S3 : Repair the levee slope damaged by vehicle traffic and prevent access where possible.					
Inspector Comment					
Repair slope damage caused by ATV, Spring 2019.

View of ruts caused by vehicle on the landside levee slope.

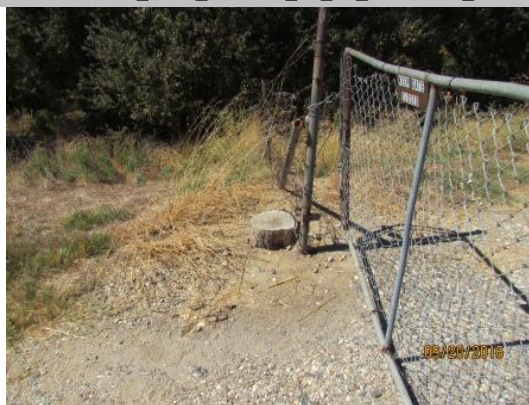
Photo 1 of 1 : SP_2019_RD1001_38_60_20190305_00031.jpg

View of tree stump, waterside crown at gate.

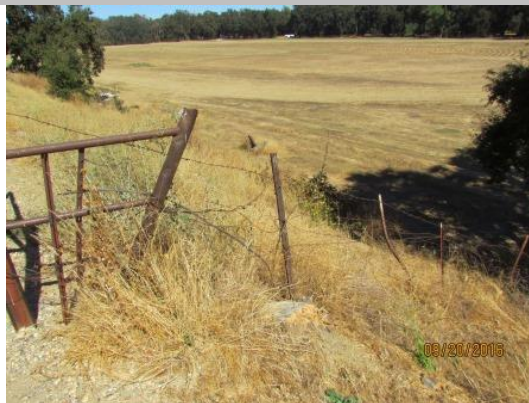
Photo 1 of 1 : SP_2019_RD1001_38_61_20190305_00032.jpg

View of tree stump, landside crown at gate.

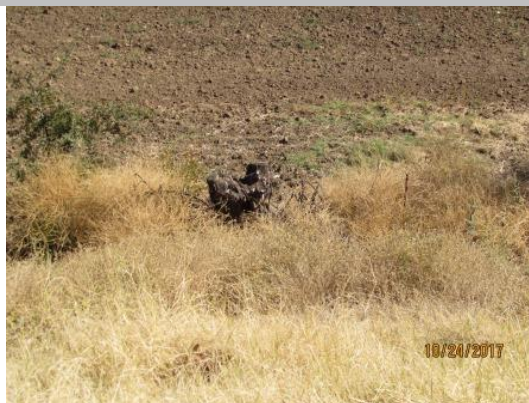
Photo 1 of 1 : SP_2019_RD1001_38_69_20190305_00039.jpg

View of landside toe of a stump that needs to be removed.

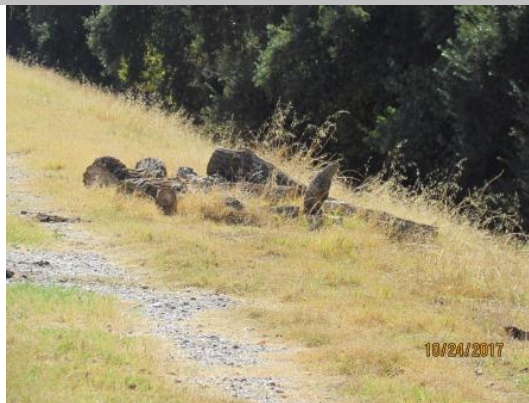
Photo 1 of 1 : SP_2019_RD1001_38_65_20190305_00035.jpg

View looking downstream waterside crown at firewood.

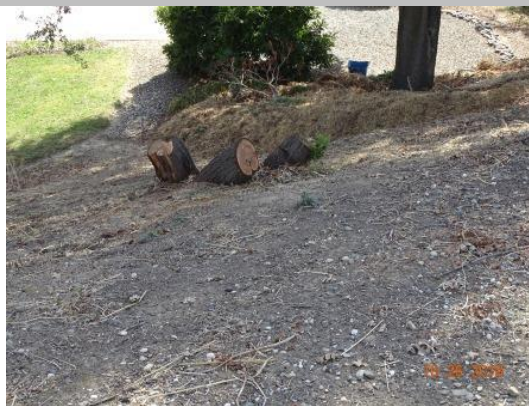
Photo 1 of 1 : SP_2019_RD1001_38_71_20190305_00041.jpg

View looking landside at stumps from a fallen and removed tree, Fall 2018.

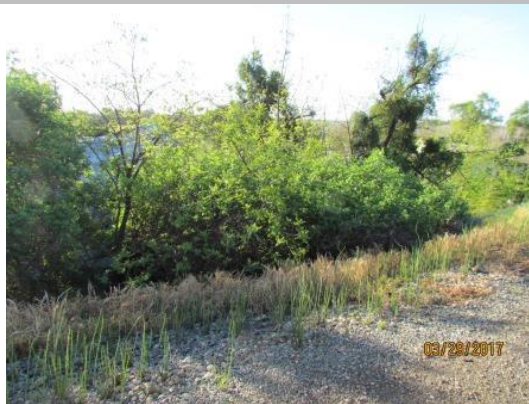
Photo 1 of 1 : SP_2019_RD1001_38_47_20190305_00024.jpg

View looking downstream where limbs need to be trimmed 5' for visibility.

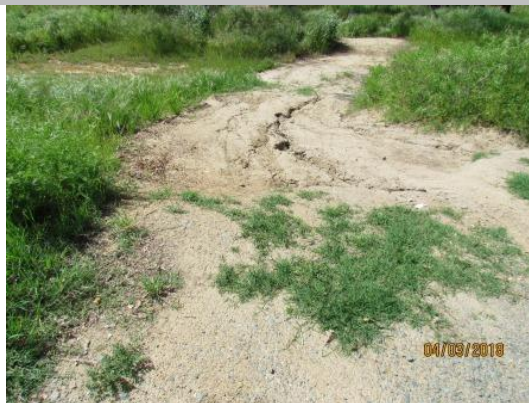
Photo 1 of 1 : SP_2019_RD1001_38_70_20190305_00040.jpg

LM Start	5.18	Rating **	M	Issue No.	70
LM End	5.18	Issue Type +	Ma	Location *	WS
Category	Earthen Levee			GPS Latitude/Longitude	
				Start	End
Item	Slope Stability			38.882301 °	38.882301 °
				-121.611296 °	-121.611296 °
DWR ID	DWR_RD1001_04_f_2017_70				
Comment Code					
S3 : Repair the levee slope damaged by vehicle traffic and prevent access where possible.					
Inspector Comment					
Continual vehicles driving up levee slope should be monitored and maintained, Fall 2018.

View looking downstream waterside of the slope that is damage by vehicle traffic.

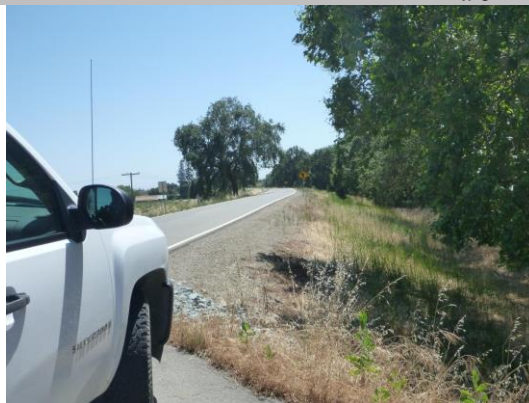
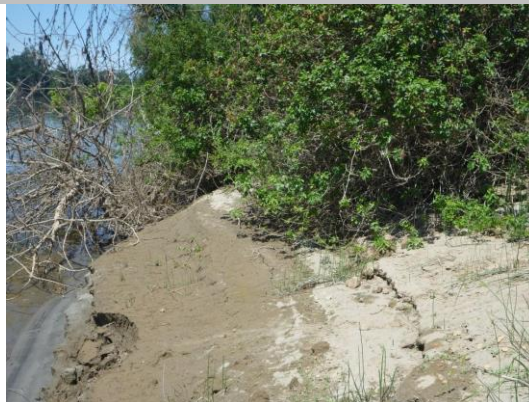
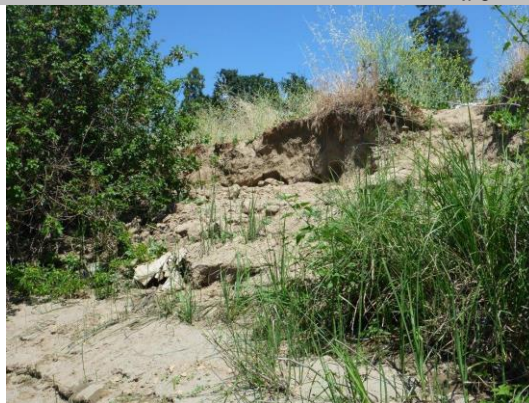
LM Start	5.61	Rating **	A/W	Issue No.	35 (cont)	
LM End		Issue Type +	Ma	Location *	WS	
Category	Supplemental			GPS Latitude/Longitude		
				Start	End	
Item	2017 Storm Damage			38.876374 °		°
				-121.613425 °		°
DWR ID	DWR_RD1001_04_f_2017_35					
Comment Code						
Inspector Comment						
Levee Evaluation Comments						
Description:						
Site ID No:139						
Site Designation:LMA-19						
Repair Type: Erosion						
Rating:Area of Concern						
Field Date:6/6/2017						
Notes: Several small erosion sites along 2 miles.

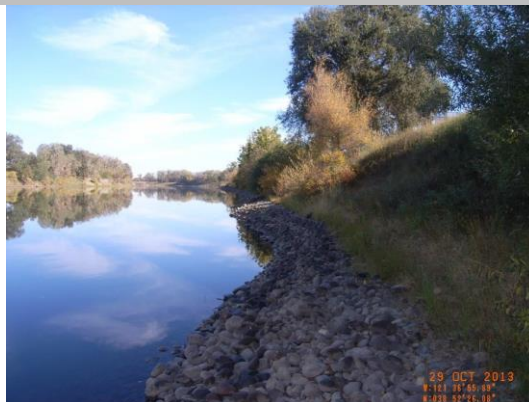
Photo 1 of 1 : SP_2019_RD1001_38_28_20190305_00013.jpg

LM Start	5.80	Rating **	A/W	Issue No.	28
LM End	5.93	Issue Type +	Ma	Location *	WS
Category	Supplemental			GPS Latitude/Longitude	
				Start	End
Item	2017 USACE Erosion Survey, DRAFT			38.874113 °	38.872373 °
				-121.615380 °	-121.616504 °
DWR ID	DWR_RD1001_04_f_2018_28				
Comment Code					
Inspector Comment					
2017 Site ID: FHR 6.6 L					
Status: Eroding					
2017 Field Notes: Sandy bank slope is unraveling.					
Site History: 2011 - Erosion pockets from tree popouts. Sections of the lower bank have slumped off. 2013 - Scallop from tree popouts no longer visible on site. Minor new erosion at the middle of the bank.					
2015 - Fresh erosion from human usage.

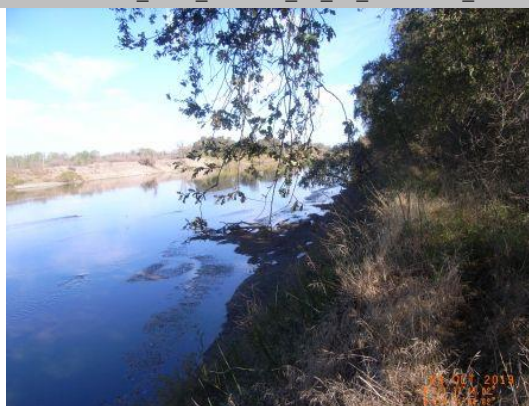
Photo 1 of 1 : SP_2019_RD1001_38_18_20190305_00007.jpg

LM Start	6.42	Rating **	M	Issue No.	18
LM End	6.51	Issue Type +	Ma	Location *	WS
Category	Supplemental			GPS Latitude/Longitude	
				Start	End
Item	2017 USACE Erosion Survey, DRAFT			38.865875 °	38.864706 °
				-121.619983 °	-121.620813 °
DWR ID	DWR_RD1001_04_f_2018_18				
Comment Code					
Inspector Comment					
2017 Site ID: FHR 6.0 L					
Status: Critical					
2017 Field Notes: Upgraded to critical, entire bank slope is slumping, with near vertical face					
Site History: 2011 - Tall slumping sections. Scour around trees has exposed most of the roots. 2016 - Recent large slope failure observed.					
Inspector notes: The erosion is not into the levee prism. Spring 2019.

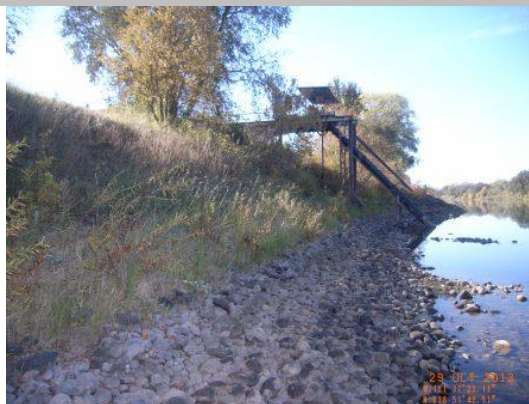
Photo 1 of 1 : SP_2019_RD1001_38_15_20190305_00005.jpg

LM Start	6.57	Rating **	A/W	Issue No.	15
LM End	6.77	Issue Type +	Ma	Location *	WS
Category	Supplemental			GPS Latitude/Longitude	
				Start	End
Item	2017 USACE Erosion Survey, DRAFT			38.863946 °	38.861558 °
				-121.621388 °	-121.623316 °
DWR ID	DWR_RD1001_04_f_2018_15				
Comment Code					
Inspector Comment					
2017 Site ID: FHR 5.8 L					
Status: Eroding					
2017 Field Notes: slope is not stable enough to maintain vegetation growth, new erosion					
Site History: 2011 - Large slumped sections on the lower bank. 2012 - New cracks observed.

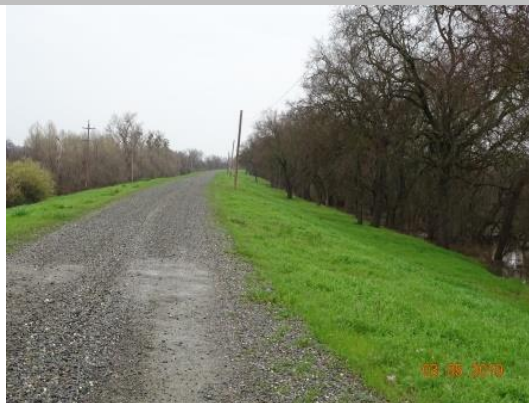
Photo 1 of 1 : SP_2019_RD1001_39_14_20190320_00021.jpg

View looking upstream waterside at the well maintained annual vegetation, Spring 2019.

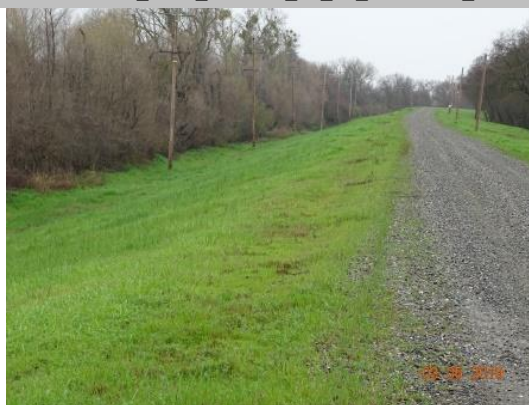
Photo 1 of 1 : SP_2019_RD1001_39_12_20190320_00020.jpg

View looking upstream landside at the well maintained annual vegetation, Spring 2019.

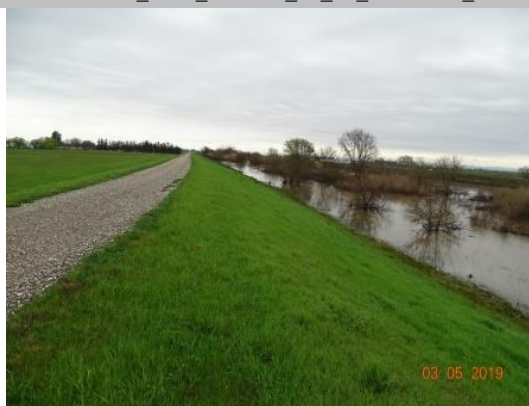
Photo 1 of 1 : SP_2019_RD1001_40_14_20190320_00038.jpg

View looking upstream waterside at the well maintained annual vegetation, Spring 2019.

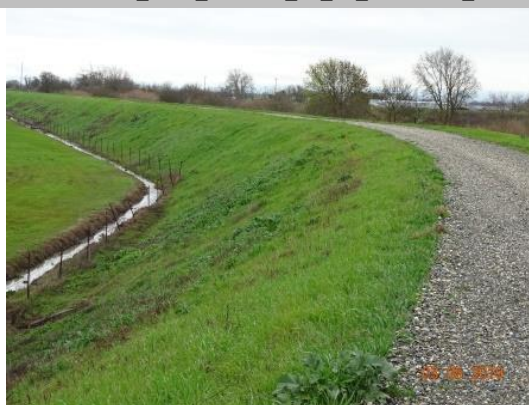
Photo 1 of 1 : SP_2019_RD1001_40_13_20190320_00037.jpg

View looking upstream landside at the well maintained annual vegetation, Spring 2019.

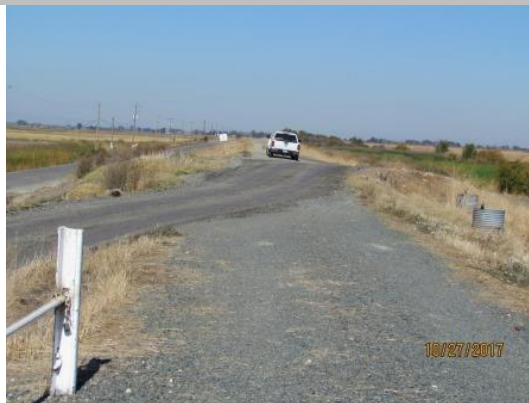
Photo 1 of 1 : SP_2019_RD1001_40_8_20190305_00003.jpg

View of crown where there is cross traffic looking upstream. Monitor this area and fix as needed.

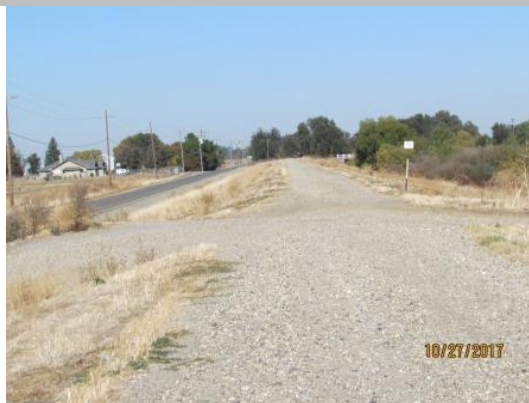
Photo 1 of 1 : SP_2019_RD1001_40_7_20190305_00002.jpg

View of crown where there is cross traffic looking upstream. Monitor this area and fix as needed.

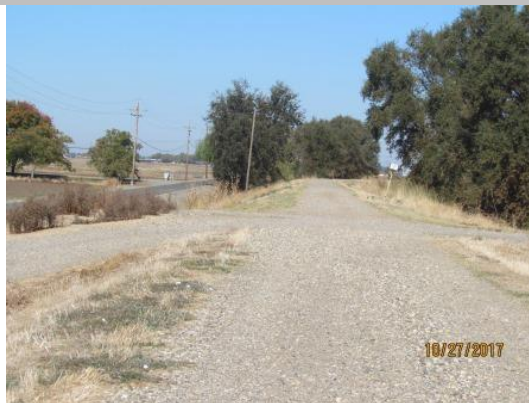
Photo 1 of 1 : SP_2019_RD1001_40_19_20190305_00006.jpg

View of crown where there is cross traffic looking upstream. Monitor this area and fix as needed.
